**Location:** 1234 Lonestar Lane, Big Sky, TX 12345

**Date:** February 28, 2017

# PROPERTY INSPECTION REPORT

By: **Jonathan Allen TREC lic# 20309**

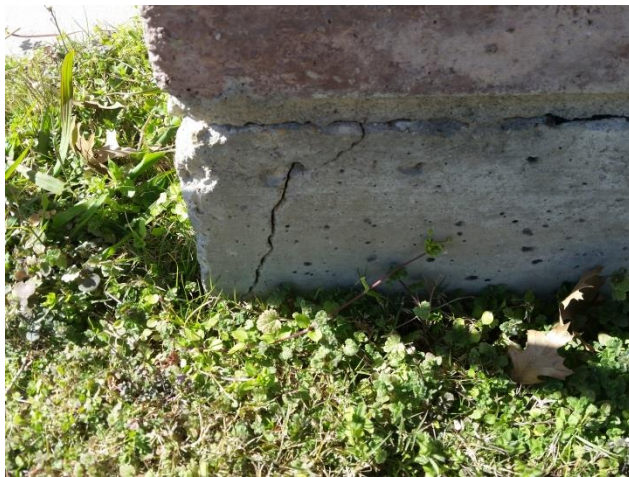
**NOTE: Small cracks were noticed on the corners of the concrete slab on grade foundation. (Corner pop/wedge crack) The condition is not typically of structural concern, though if the corner cracks are obstructed they may be conducive to hidden wood destroying insect entry.**

The large majority of slab-on-grade foundations will develop what are called corner cracks or wedge cracks. The name comes from the fact that these cracks develop at or very close to the corner of the foundation and frequently form a wedge shape. They are also referred to as "corner-pops". These corner cracks do not indicate anything unusual about the foundation. In extreme cases the corner cracks are large enough that they no longer support the bricks immediately above it and will need to be repaired. This is a concrete repair and not a foundation repair.

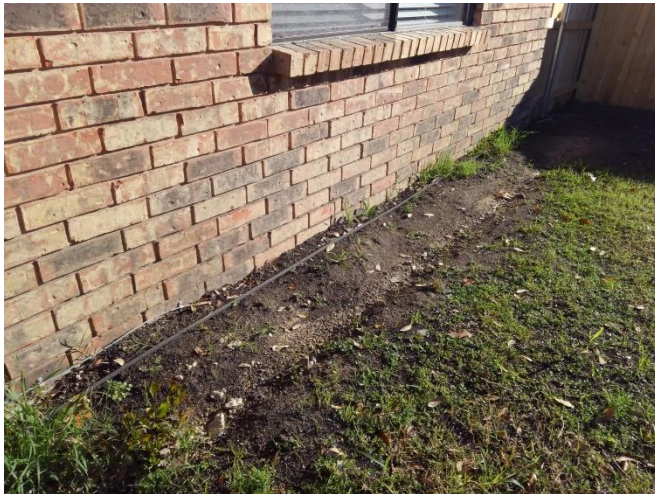
- Heavy landscaping/vegetation should be trimmed so that the perimeter beam of the slab is visible in all locations around the house.
- Soil levels in some areas at the perimeter of the foundation are too high. Code and common building practice requires a clearance of 6 inches from the bottom edge siding to finished grade and 4 inches from the bottom of masonry veneer to siding.

**NOTE:** According to my standards of inspection through TREC the steps leading down to the lower back lawn area should have a proper handrail.

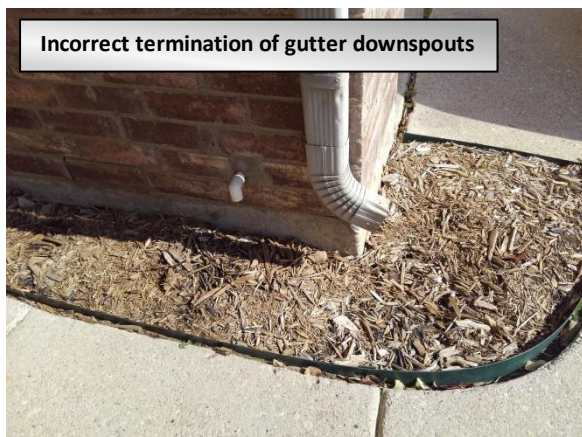
**NOTE:** The gutter downspouts should discharge water at least thirty-six inches (36") away from the foundation perimeter beam. Storm water should be encouraged to flow away from the structure at the points of discharge.

**FYI:** The most common way that splash blocks are positioned is incorrect. One naturally feels that a splash block should be positioned with the lip behind the flow of water. The splash block should be positioned so that the lip is at the end of the flow of water in order to splash the water out more properly dispersing the storm water.

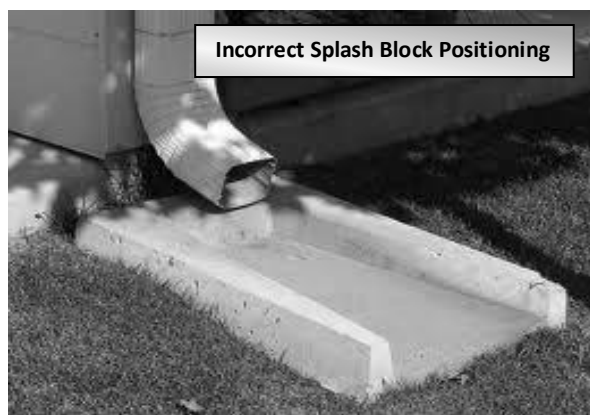
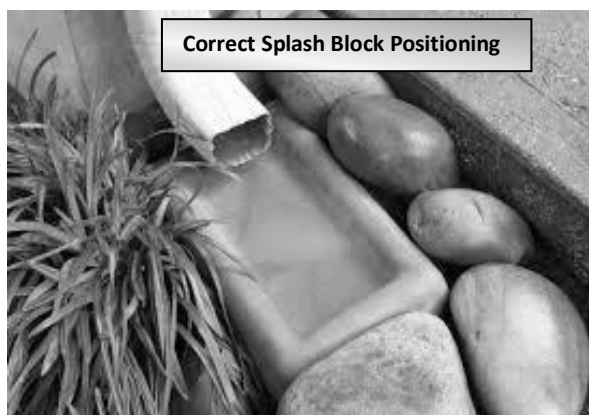
- Gutters are congested and are in need of cleaning.
- Some leaks at the joints of the gutter eaves troughs were observed.

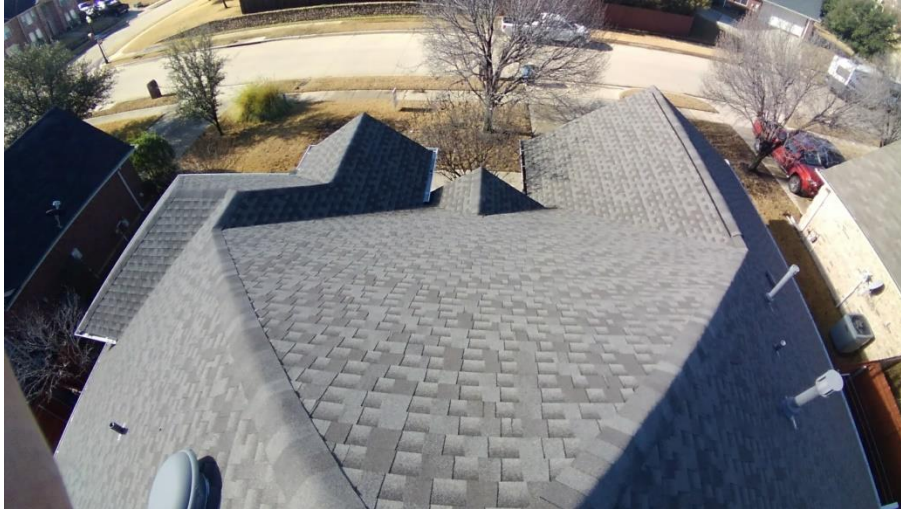
**Roof covering materials appear to be performing as designed on the day of the inspection. Some premature mechanical damage/foot traffic was observed. The observation made to support the rendering of this opinion are listed but not limited to the following:**

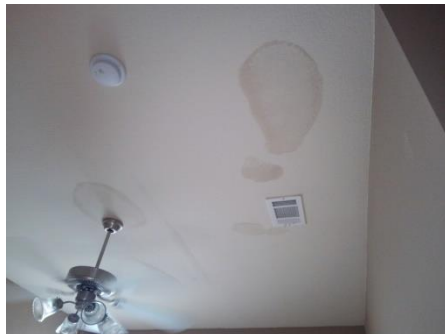
- **Evidence of water intrusion observed in one or more locations including the master ceiling**

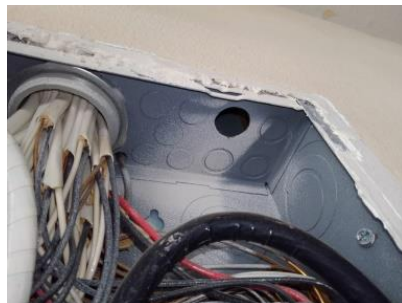
- **NOTE: Open punch out in the upper right hand corner of the service enclosure should be properly sealed shut**

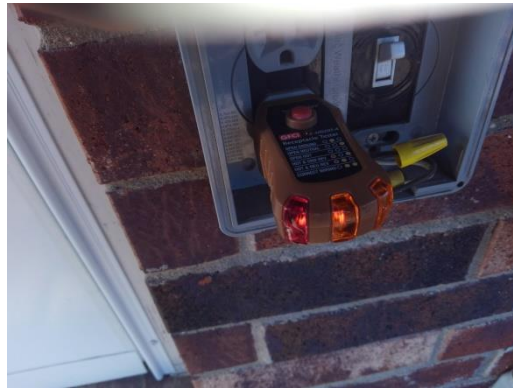
- **Receptacle at the back porch has not been properly wired. It would appear that the ground and neutral wire may be reversed. This receptacle is not currently GFCI protected. Open wire splice was observed inside the cover of this receptacle.**

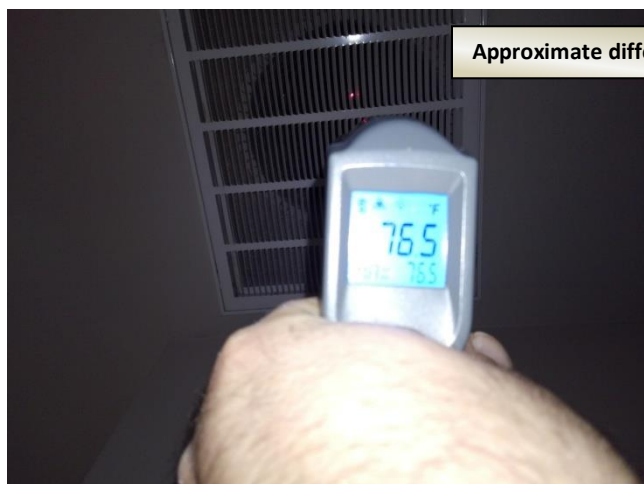
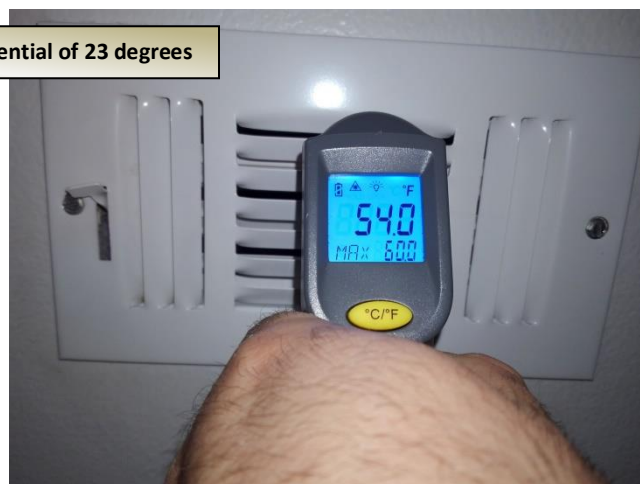
**Return: 77 degrees. - Supply: 54 degrees. = Differential: 23 degrees.**

**\*(A normal Temperature Differential is considered by our standards to be between 15 and 23 degrees.)**

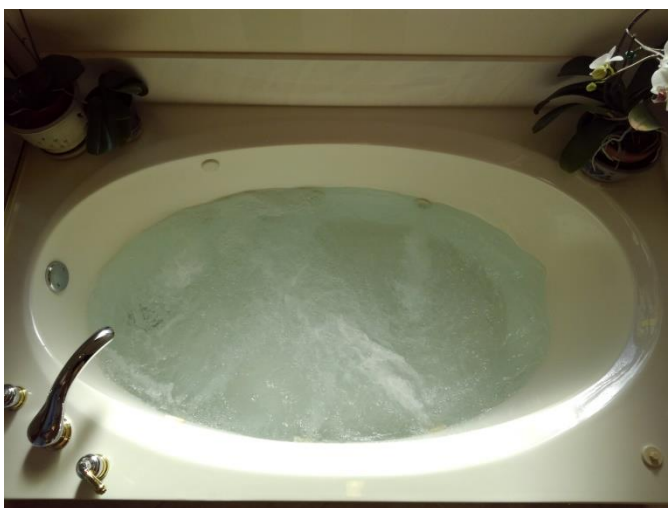
*Underside of tub readily accessible:* **yes**

**This component appears to be in satisfactory condition and functioning as designed at the time of the inspection.**

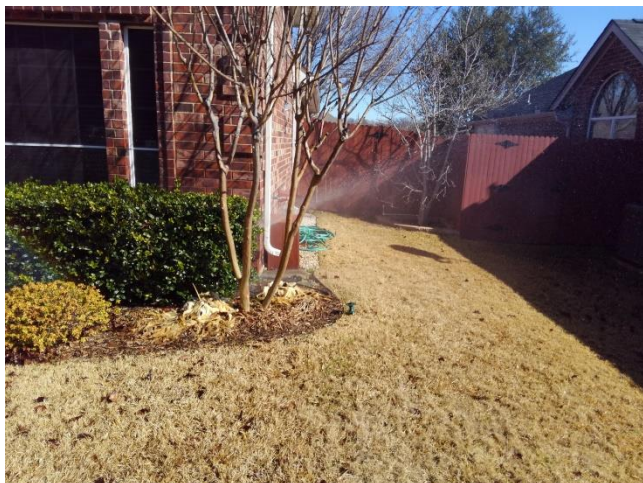
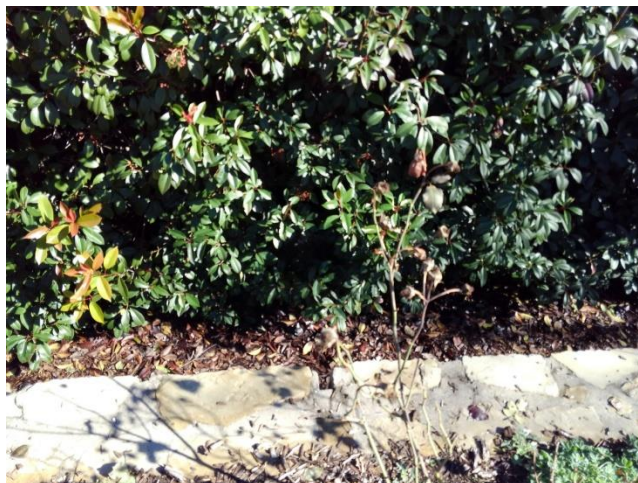
- One or more sprinkler heads appear to be damaged/broken under in stations 1,2,5 and 7 are in need repair. (each station should be manually activated in order to see the leak/break/malfunction)
